Casement Window Restoration

November 14-29, 2011

Evanston, Illinois

Caseмент Window Restoration Study

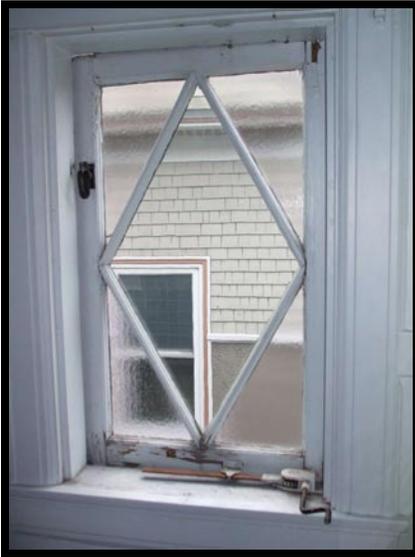
1.) 2nd floor casement window prior to removal.

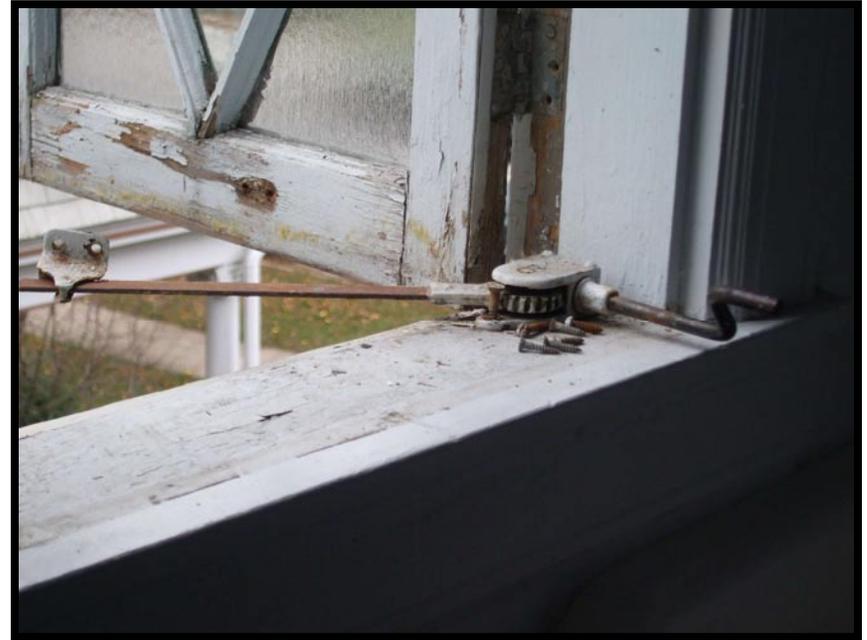
3.) 2nd floor casement sash operator

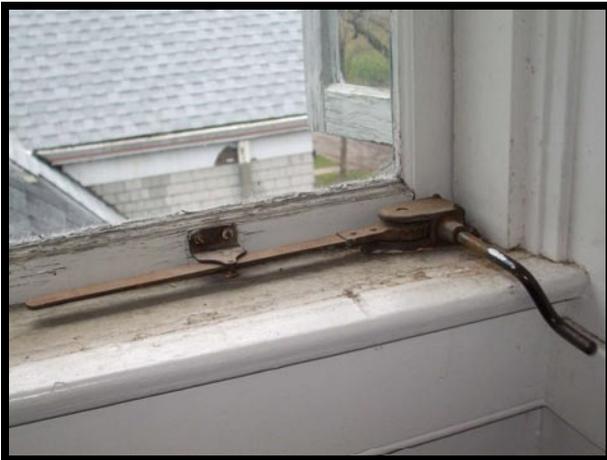
4.) 3rd floor casement window sash operator

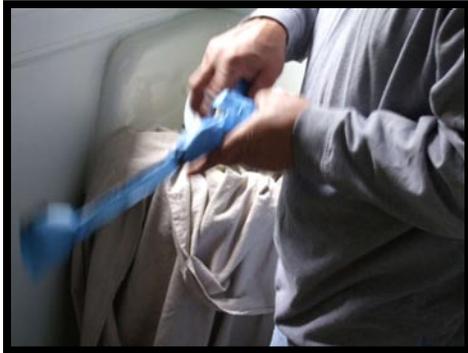
6.) The casement hardware is wrapped with painter's tape and labeled.

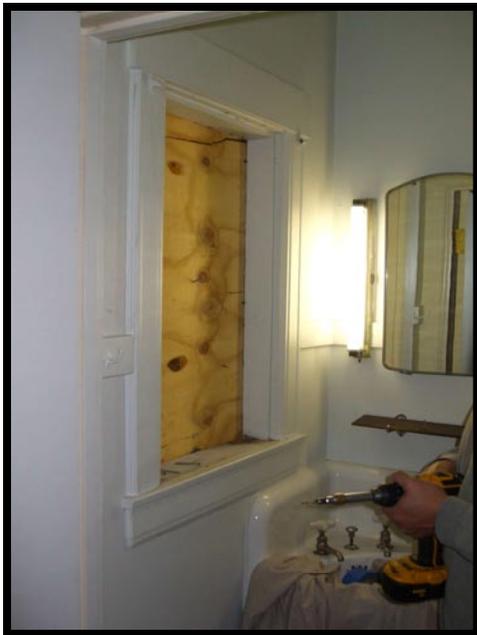
7.) Plywood is installed temporarily with drywall screws driven into the jamb. Painter's tape was applied to prevent air infiltration.

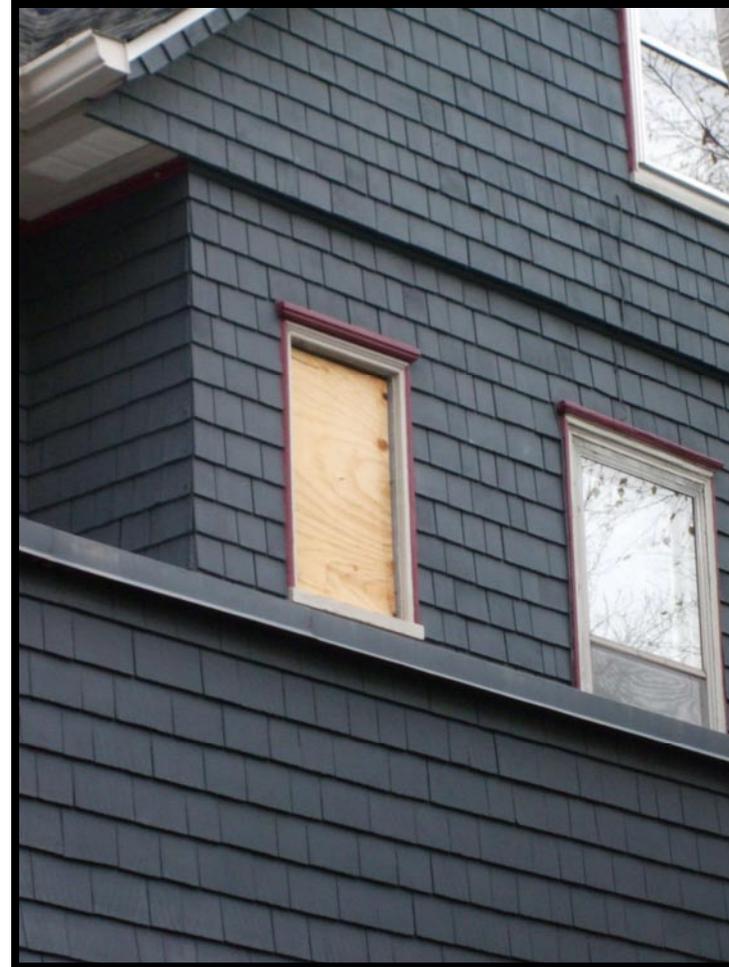
8.) 2nd floor window from the exterior after removal of the window sash.

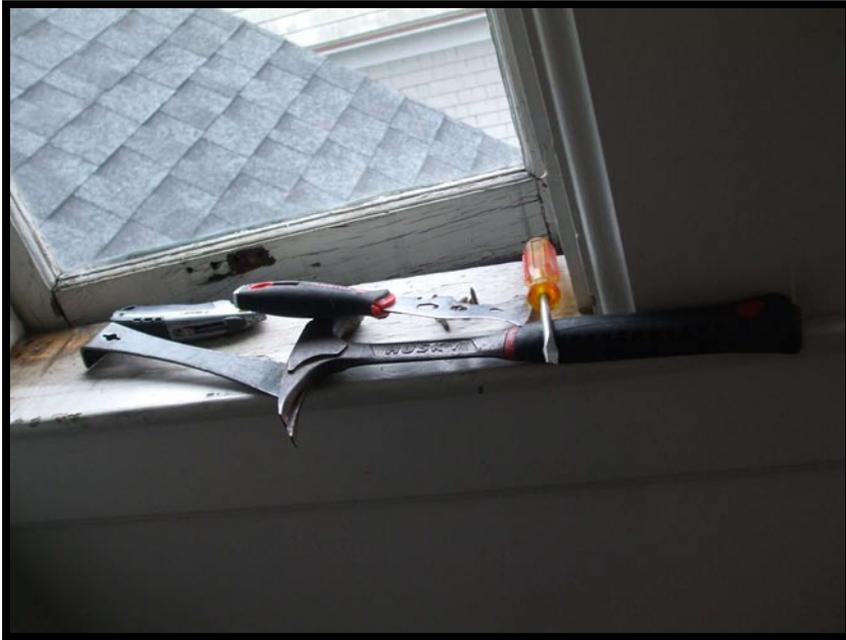
12.) Tools for this phase.

“Tools for this phase” (photograph #12) included a cordless drill, a vacuum with a filter, a circular saw, saw horses, a screwdriver, a putty knife, a hammer, a small pry bar, an utility knife, and a 5-in-1 painter's tool.

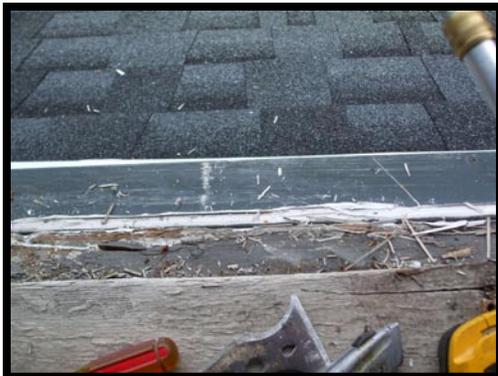
13.) Rot at 3rd floor sill. A partial earlier repair by another contractor was discovered.

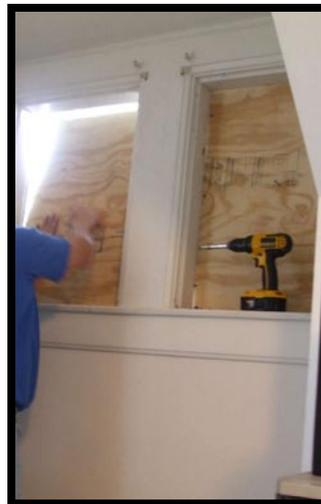
14.) Plywood panels installed following removal.

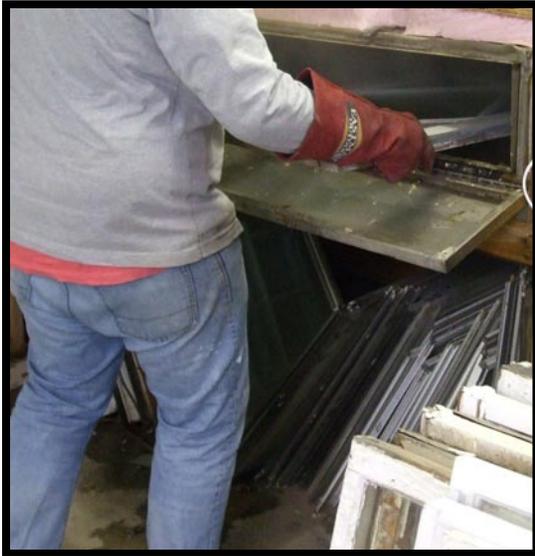
16.) Window placed in a steam box.

Steam removal of lead paint is gaining in popularity due to the following advantages over other methods:

- 1.) It eliminates the risk of fire due to the paint removal process.
- 2.) It minimizes lead-dust health risk because it is a damp process.
- 3.) Steam removal does not cause the fumes of other heat removal techniques.
- 4) For most projects the cost of steam paint and glazing removal is relatively low.
- 5.) Operating and supply costs are much lower than chemical paint strippers.
- 6.) Disposal costs are relatively low.²

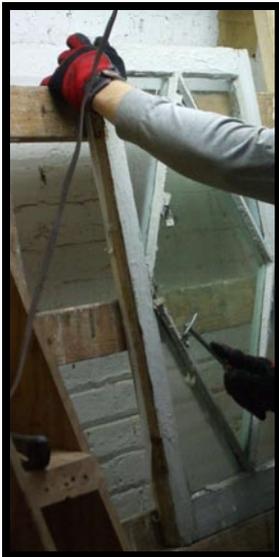
19.) Paint and putty scraping, removal.

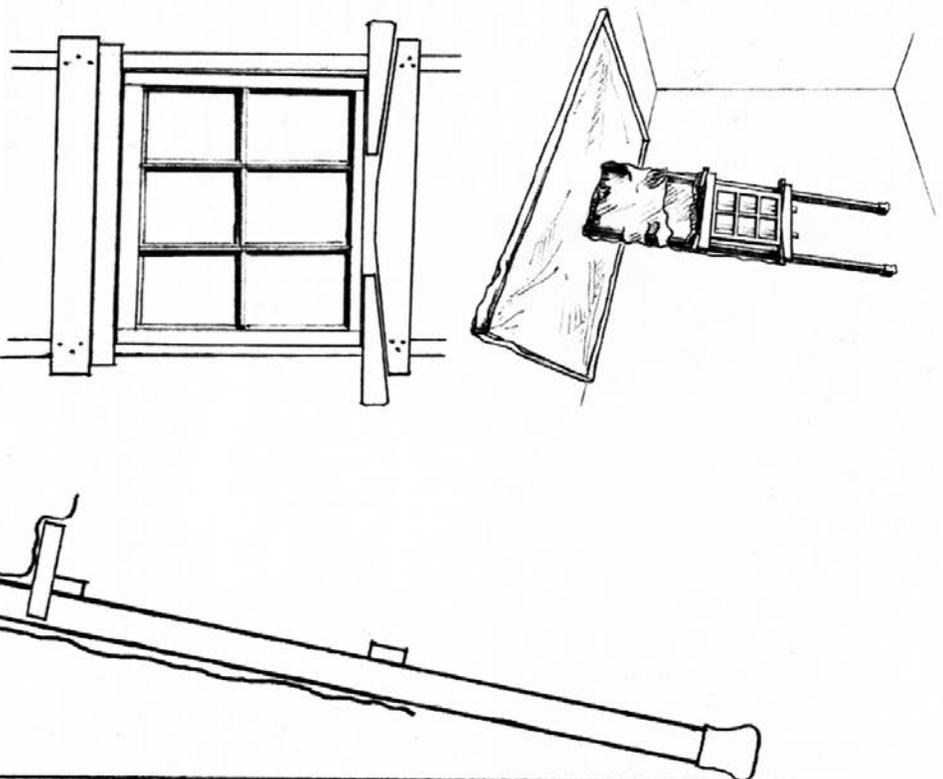
This sash easel is a good demonstration of how to set up for lead paint removal and to make repairs on wooden sash.³

The window sash easel holds sashes at a convenient height to reduce fatigue and back pain during long production work sessions. A skilled carpenter can easily construct one in 30 minutes from three 2x4s, 8 feet of 1x2 wood furring strip, 1 dozen 3", and one dozen 1 1/2" wallboard-style screws. Adjust the height of the two rails so the middle of the sash is at the worker's elbow. The top rail is tapered on the same angle as the wedges. Set the separation of the rails to accommodate the width and height of the sash. The sash is clamped down and held steady by the two wedges above, and can be easily repositioned, rotated and flipped by loosening and re-driving the wedges. A spacer block resting on the lower rail makes up the difference between the width and height of the sash in different positions.

A supply of 6-mil poly-sheeting and duct tape is needed to form the debris containment that wraps down the front of the easel and up the backside to the top of the sash. Tape up the side edges of the poly to form a bag around the lower section of the easel. Lead containing debris from deglazing and paint removal falls into the poly containment. A HEPA vacuum can be attached to the containment to draw fine dust particles into the containment. When the containment is about half full it can be slid off the easel and disposed of without spreading the dusty debris all around the work area.

The easel can be taken apart and screwed into a narrow pack for hauling and storage. When a project is complete, an easel can be left at the site for ongoing sash maintenance, repair and painting.

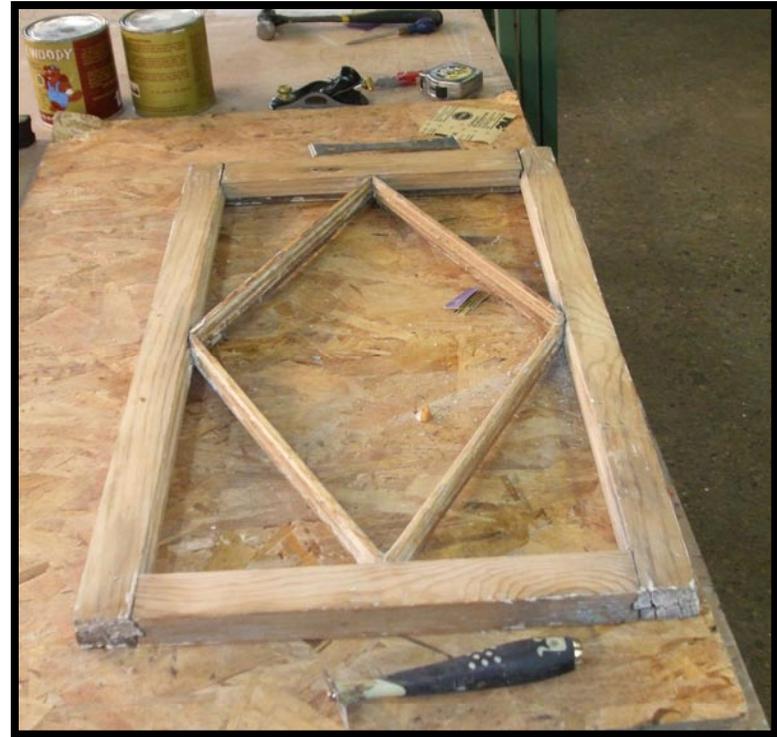
23.) [Day 2] Much of the paint has been removed.

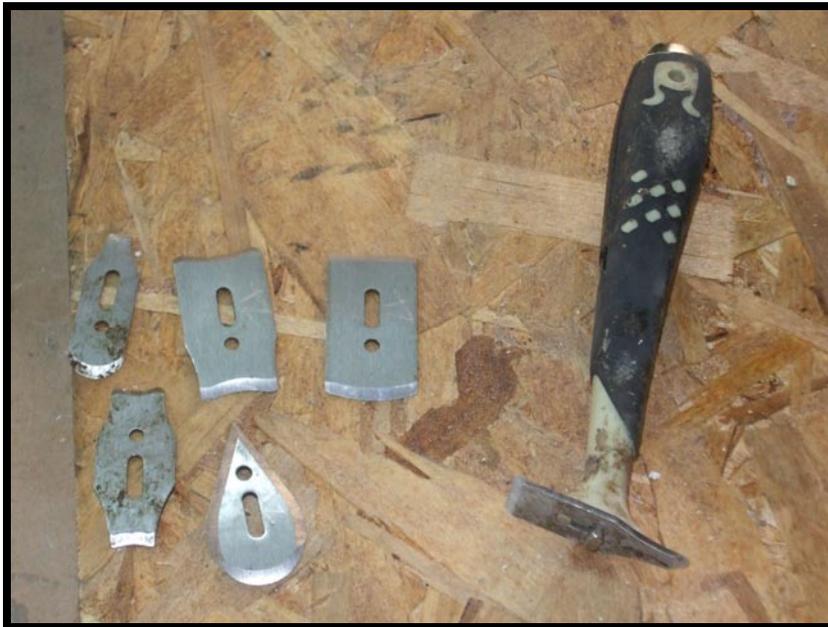
24.) Scraper attachments for paint removal.

Having a variety of scrapers on hand to remove paint is quite useful. These conform to different mouldings and irregular surfaces found on rails, stiles, and muntins.

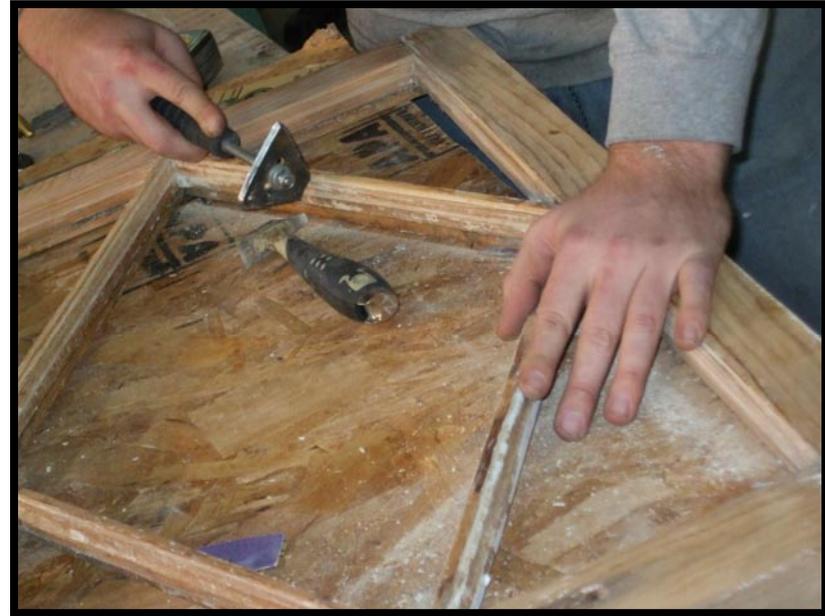
26.) Scraping paint from the window muntins.

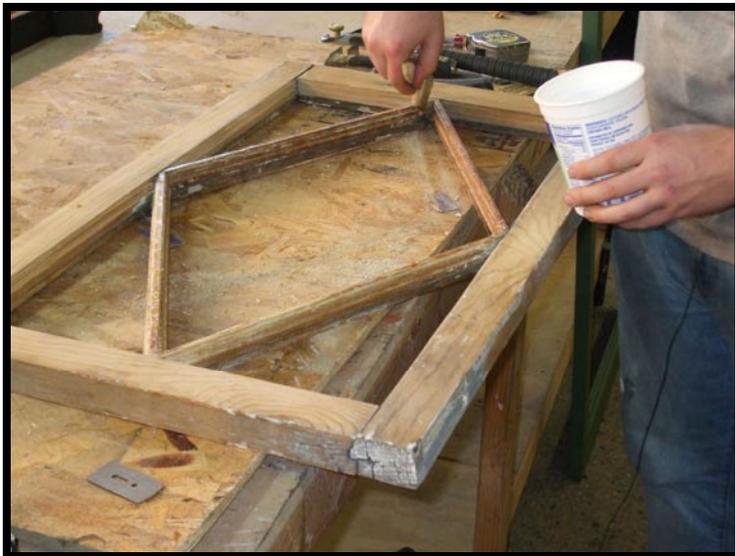
27.) Paint remover applied to aid in scraping paint from the window muntins.

In photograph #27 a small amount of paint remover is used to remove paint residue from areas which are hard to reach. When using a chemical stripper it is important to clean off the remaining chemical residue from the wood surface with a manufacturer recommended cleaning solvent. Which solvent to use depends upon the composition of the paint remover, especially since some chemical strippers are water based.

Cleaning off the paint remover paste and any wax that may be combined with them to form the paste is necessary as they can prevent paint adhesion.⁴

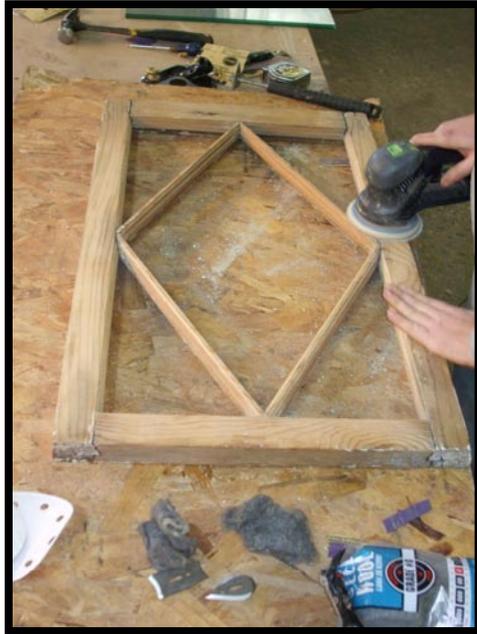
28.) Orbital sanding with HEPA vacuum attached.

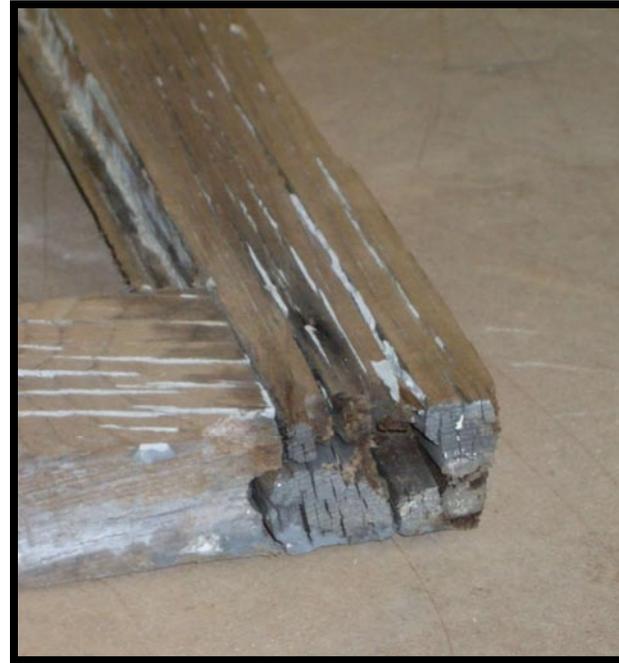
29.) Rot, deterioration on 3rd floor casement stile.

Photograph #29 shows signs of rot. Removal of severe rot should be considered first.⁵ However where decay removal is not planned or practicable, the application of wood preservatives should be implemented. Drill holes to help the preservatives penetrate deep into the wood. After applying wood preservatives, use a consolidant to harden the wood and provide a stable, clean base for adhesion to epoxy filler repairs.⁶ For more information on this process, please view the resources listed at the end of this presentation.

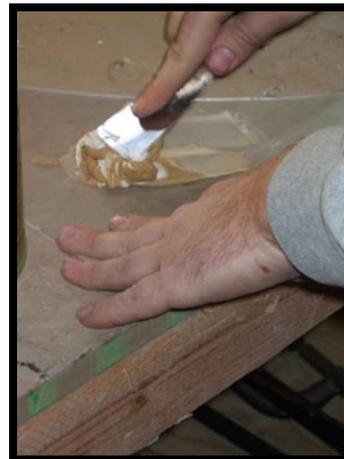
31.) Mixing equal parts of the wood epoxy.

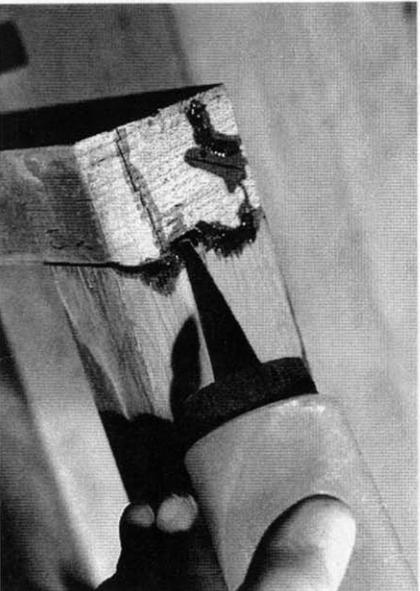
Step 4. Fill Gaps with Epoxy Filler.

On a flat board, mix a little epoxy consolidant with some of the epoxy paste filler to thin the filler's consistency. Work the thinned paste into the joint from all three sides with a putty knife. Then work in some of the thicker paste. This forces the thinner mix deep into joint. The goal is to completely fill the joint with paste.

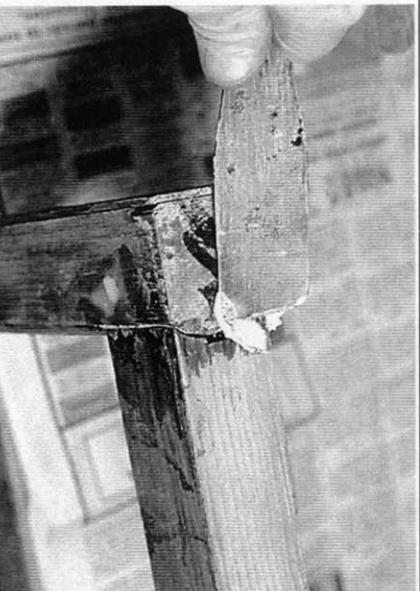
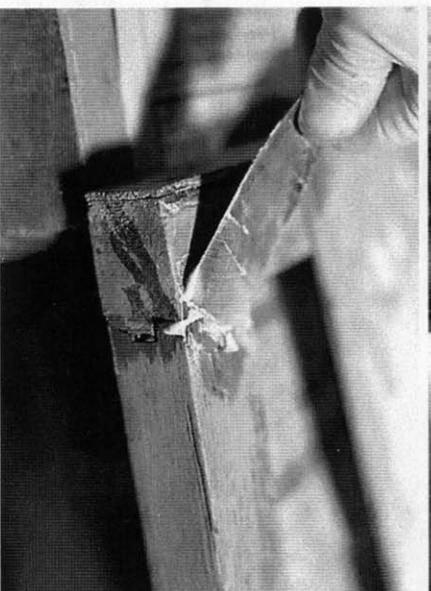
Step 5. Clamp Up. If necessary, close the joints with bar clamps. Only a light pressure is needed. Over-tightening can break the sash. Be sure the sash is flat and square. Let the epoxy cure overnight

Step 6. Trim & Sand. Trim cured epoxy from glazing rabbet and sand or scrape film of epoxy from all surfaces to expose bare wood.

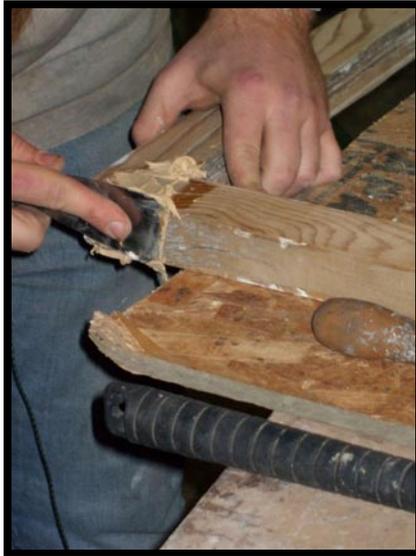
32.) Applying epoxy filler to the 2nd floor casement sash stile end grain.

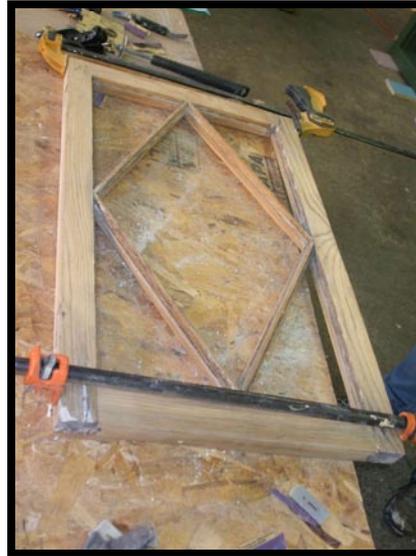
33.) Clamps placed around the frame while epoxy dries.

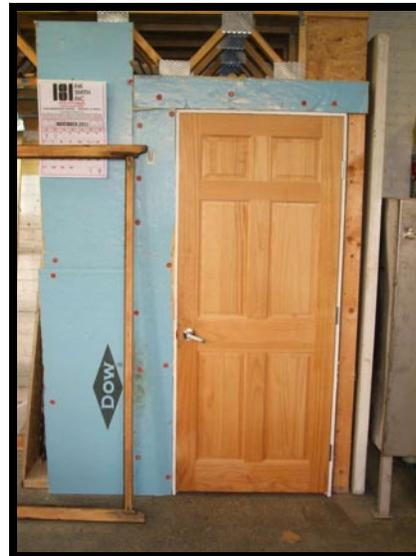
36.) The “heat room”.

Moderate heat was used to accelerate the drying process. Within a shop environment, low Fall temperatures can be avoided and materials allowed to dry more efficiently within higher recommended ranges. Note that high heat above seasonal outdoor temperatures can cause glues, epoxies, glazing compound, paint and other window components to fail.

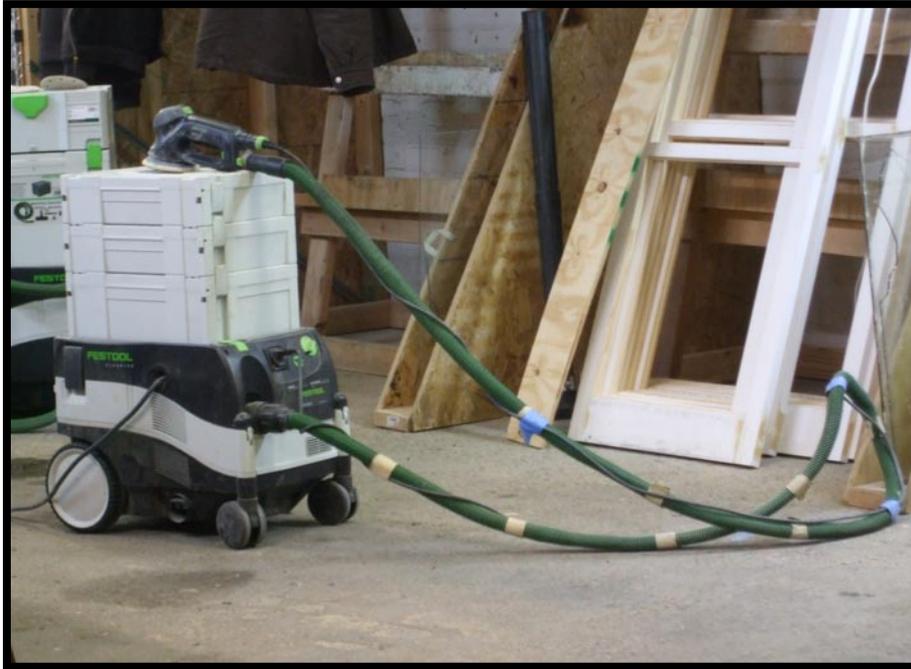
37.) A HEPA vacuum is attached to an orbital sander.

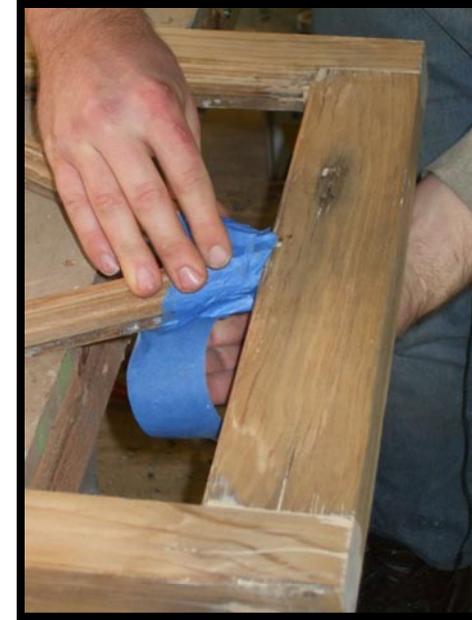
39.) Loose muntin repair: an adhesive is applied, and the joint is clamped with tape.

When repairing loose joints as in photograph #39, consider what caused the joint to fail. If rot is the cause and the rot cannot be completely removed or replaced, then wood preservatives should be applied, followed by consolidants and epoxies designed for this purpose.

Exterior wood adhesives can otherwise be used as shown in photograph #39.

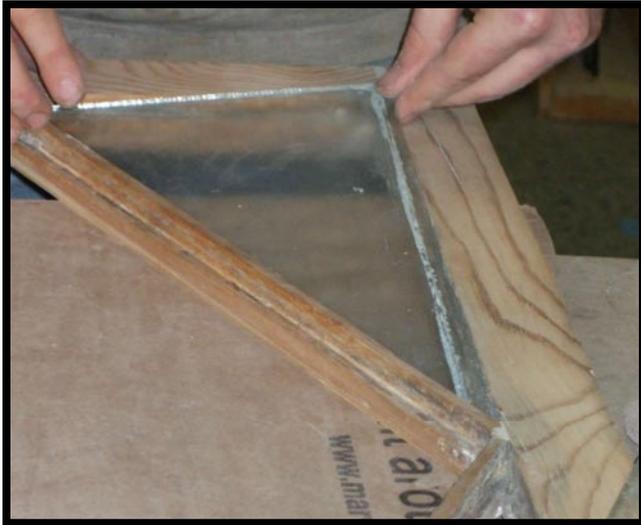
42.) Glass panes test fitted.

In fitting new glazing (glass panes) to the window, be sure to allow 1/16" gap on all sides from the rails, stiles, and muntins, or subtract 1/8" from the height and the width. This will speed installation as the edges for the glazing do not have to be absolutely precise. Cutting glass, however, can require much patience and skill.⁸

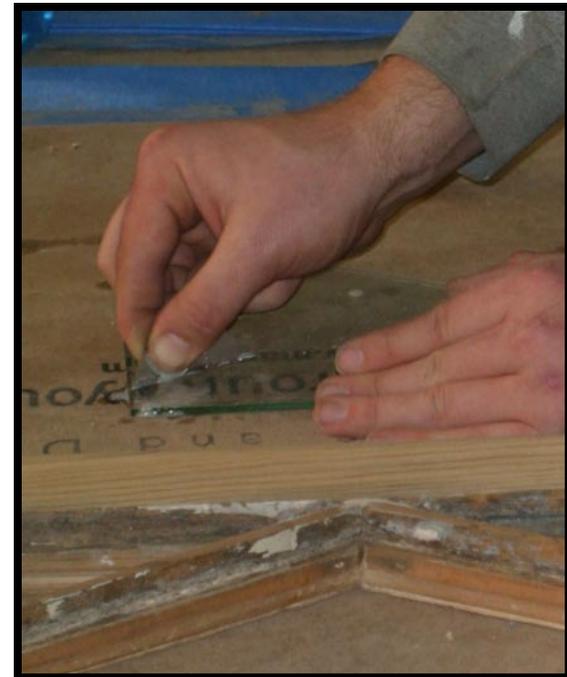
44.) Glass cleaned with window cleaner and a straight razor.

When reusing historic glazing, clean the surface of the glass thoroughly prior to reinstallation.

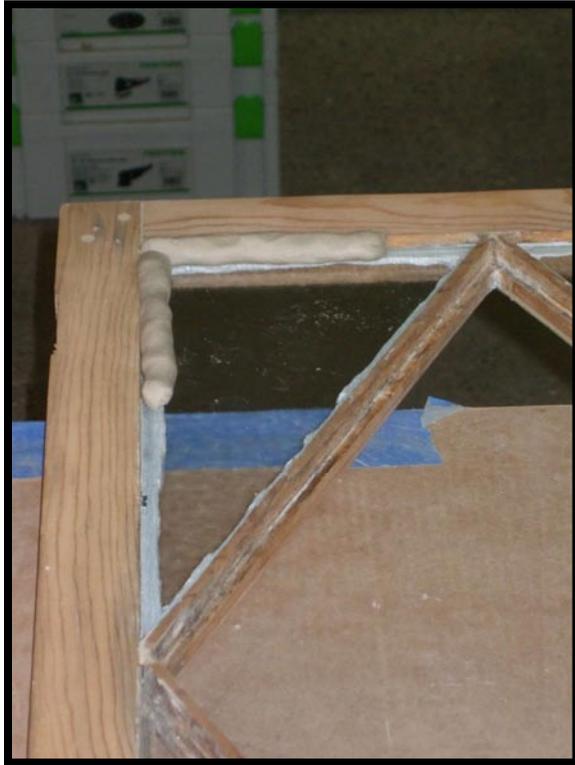
47.) The glazing compound is kneaded, rolled up and placed over the glass and glazing points.

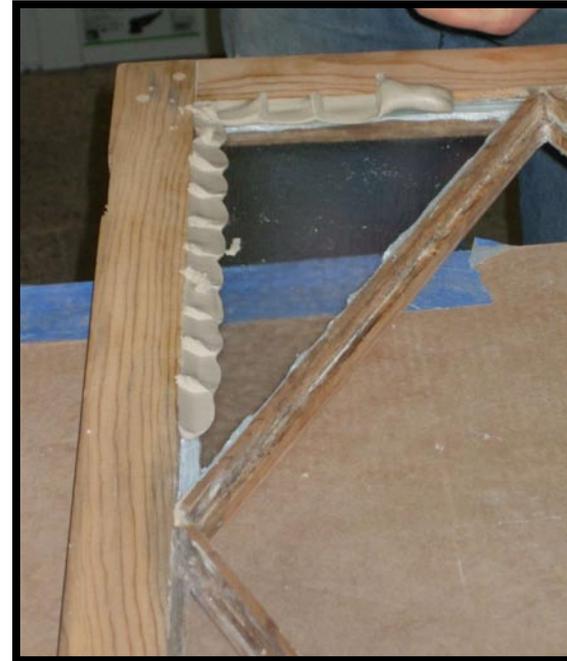
48.) Glazing compound pressed into muntins, rail, stiles with a putty knife.

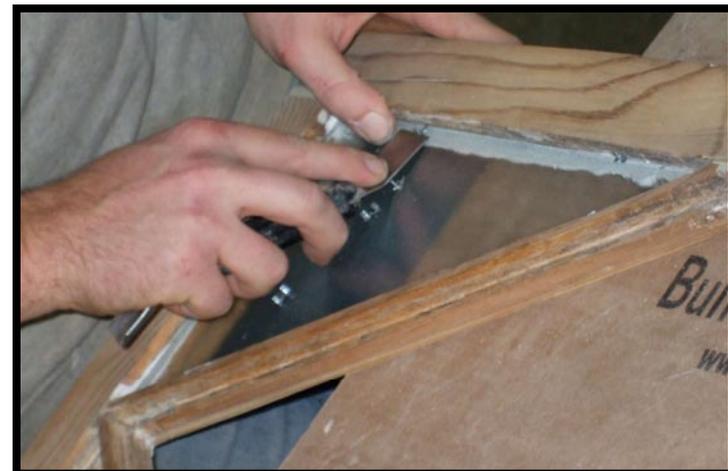
46.) Glass pane installed over glazing compound bead; glazing points installed.

In photograph #46 a bed of glazing compound was applied and the glass is pressed into the rabbet. Before installation of the glass it is frequently recommended that the bare wood should be brushed with boiled linseed oil and painted with an oil based primer to prevent the wood from absorbing excess moisture from the glazing compound, allowing the compound to dry slowly and promote better adhesion to the window sash through long term exposure to the weather.^{9,10}

Always install glazing points when installing window glass.

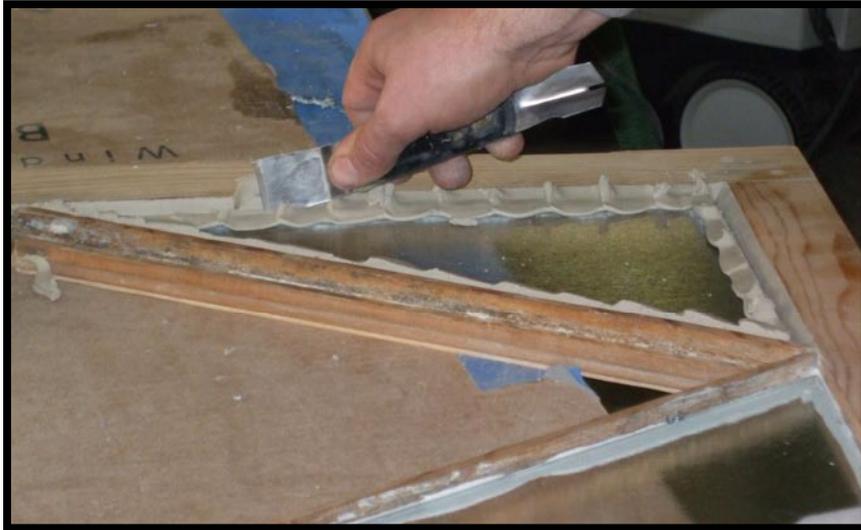
49.) Glazing putty cut to profile with a putty knife.

As shown in photograph #49, the glazing putty should visually match the profile of the wood on the opposing side of the glass. For most people, this takes some practice and skill.

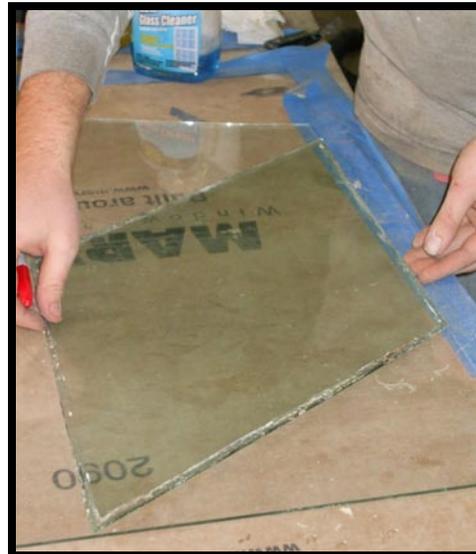
51.) Cracked center pane for the casement dimensioned for replacement.

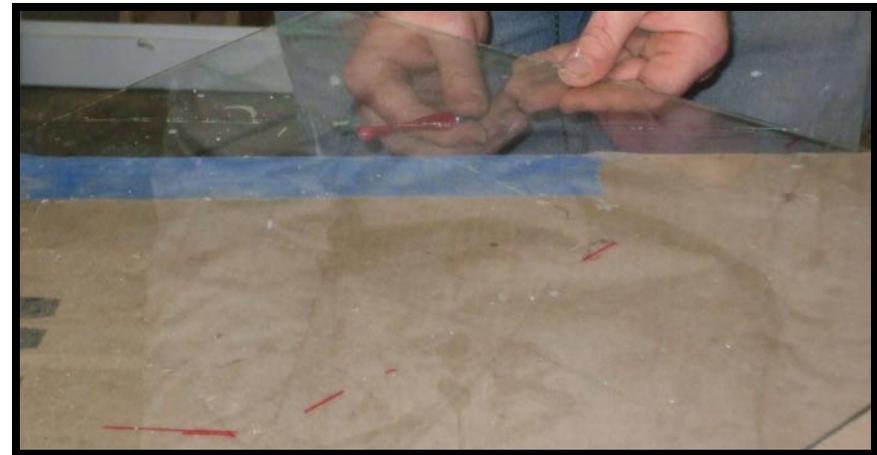
52.) Cutting a new center pane.

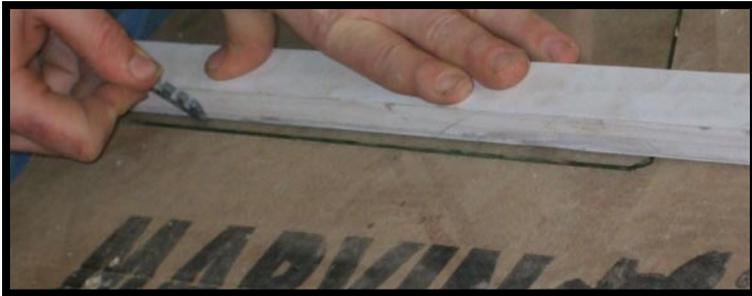
53.) Center pane is trimmed to fit 2nd floor casement muntins.

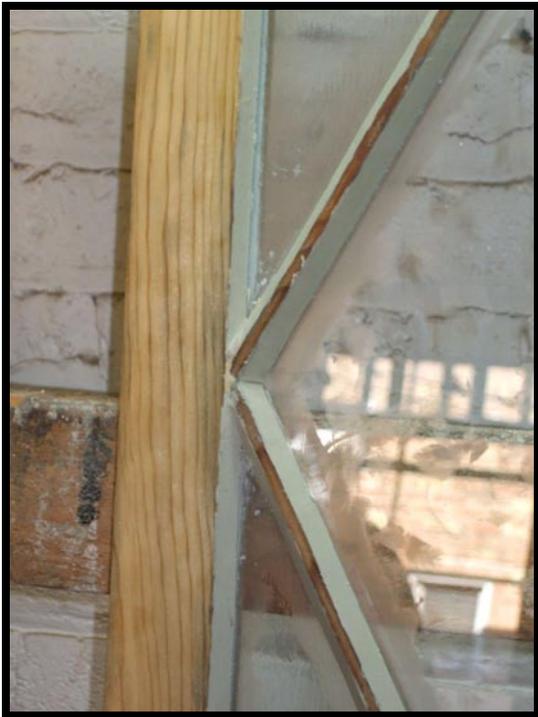
55.) [Day 4] Glazing completed. Profile of glazing putty.

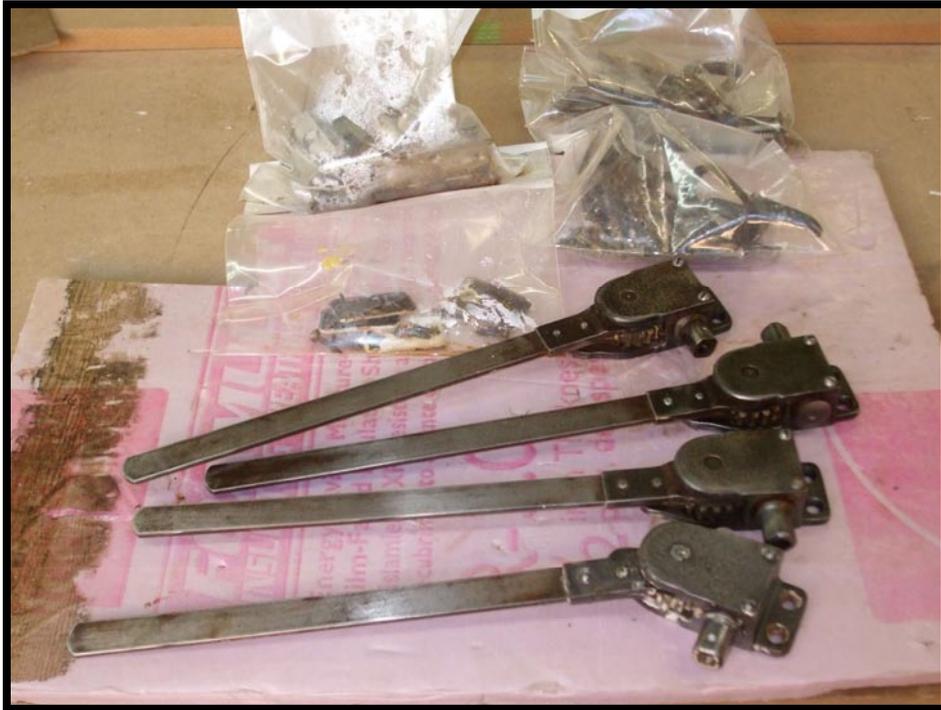
58.) Casement operator hardware and sash hardware undergoing cleaning and lubrication.

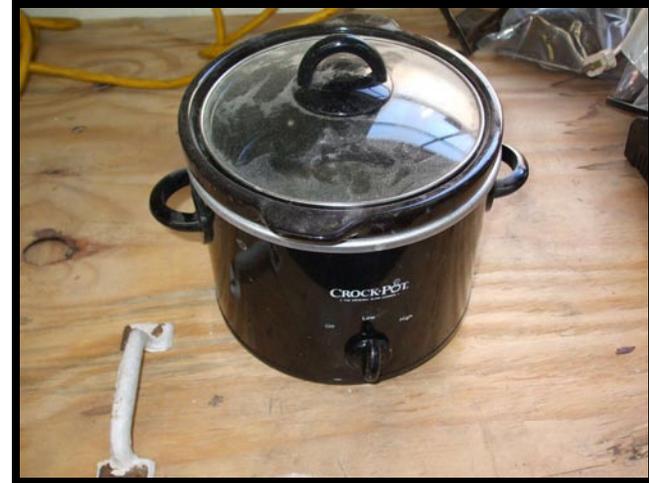
59.) Paint is loosened from hardware with TSP and hot water.

Paint removal methods for hardware vary. Soaking overnight in a container of hot water and granulated dish detergent or TSP are two examples. A stiff brush and a pair of gloves is often all that is needed to clean most hardware.¹¹

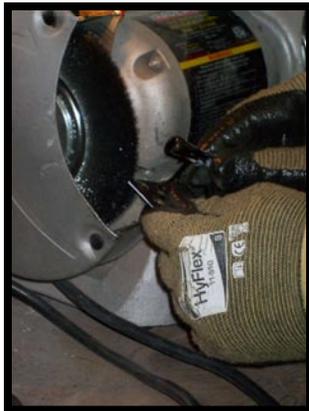
60.) Remaining paint is removed from window latch with a wire wheel.

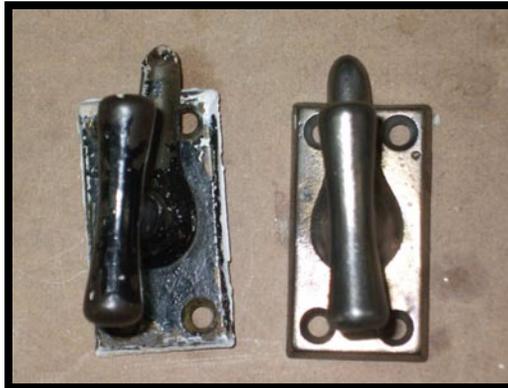
61.) Window latches prior to final paint removal with a wire wheel and after using the wire wheel on the bench grinder.

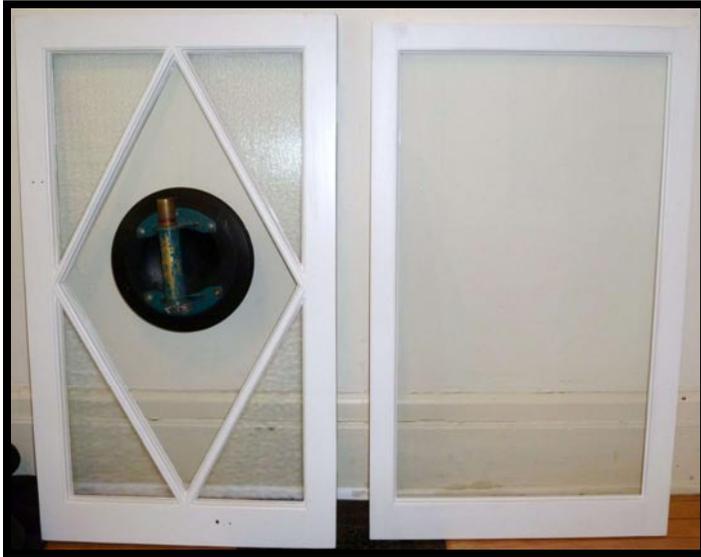
62.) A Wood's Vacuum Cup is being used to install the restored sash. An interior storm window is on the right in this photograph.

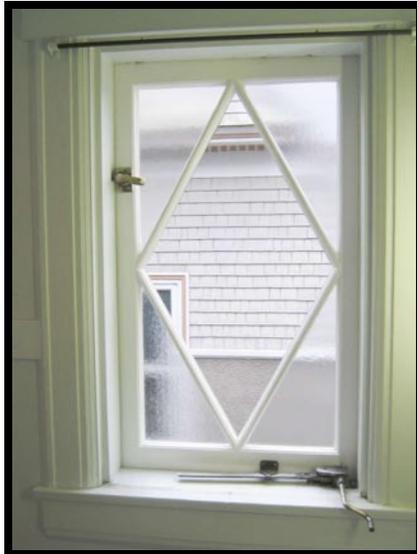
63.) The restored casement window is installed.

Final painting for this casement window was an initial coat of white primer followed by two finish coats. Latex based paints were used. Spring bronze and other varieties of weather-stripping are typical for this type of installation.¹²

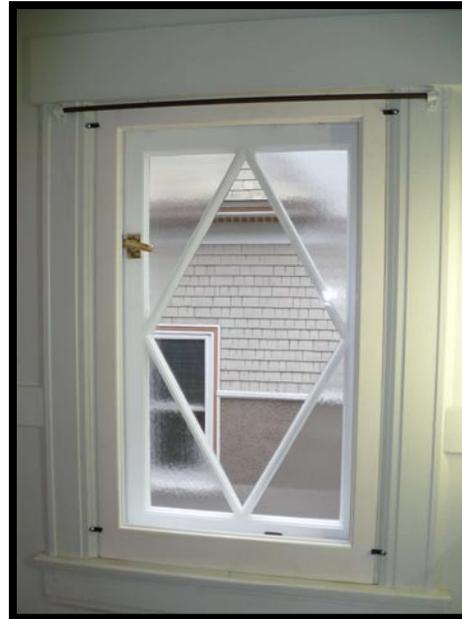
64.) The interior storm window is installed. Tabs at each corner hold the storm window in place. The casement operator crank has been removed and stored for the winter.
